Technical Report SL-99-8
August 1999

Structural Collapse: Quarter-Scale Model Experiments

by Stanley C. Woodson, James T. Baylot

Final report

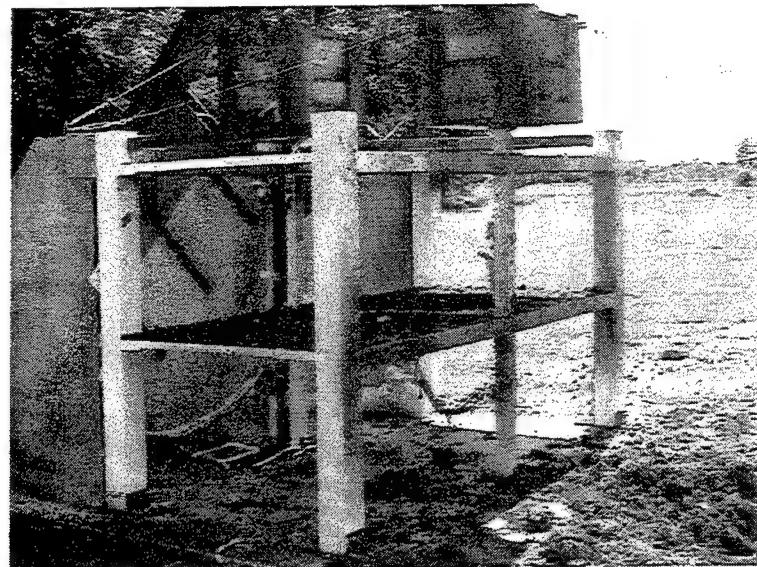
Figure 3.1 Posttest View, Experiment No. 1

Experiment no. 1 was conducted on an open frame model, using an explosives standoff distance of 5.0 feet. Figures 3.1 through 3.3 are posttest photographs. The model incurred very minor damage. Hairline cracks were visible on the test column and on the surfaces of the slabs. Permanent displacements were too small for physical measurement. The desired level of damage was not achieved. Since the damage was very minor, it was apparent that the experiments to follow with cmu walls might not produce any significant difference in damage levels. From the experimental observation, along with the results of finite element calculations (discussed in Chapter 4), it was determined that the open frame configuration should be repeated with a reduced standoff.

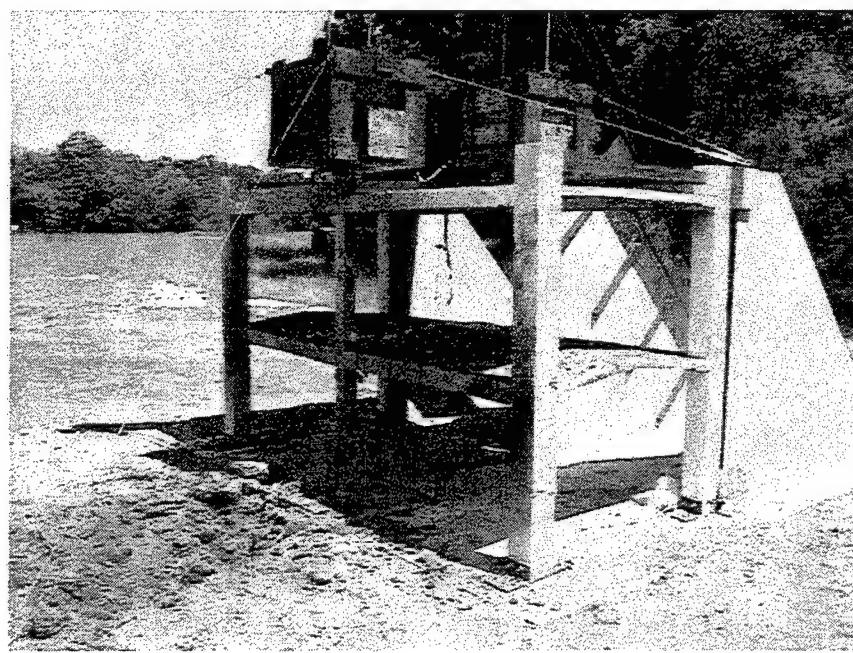
Figure 3.4 Posttest View, Experiment No. 2

The standoff was reduced to 3.5 feet, simulating 14 feet at full scale, for experiment no. 2. Figures 3.4 through 3.6 are posttest photographs. The model incurred considerably more damage than that of experiment no. 1. The lower section of the test column sustained a permanent displacement of approximately $\frac{1}{4}$ inch, but maintained its ability to carry the dead weight applied at the top. The lower slab displayed a permanent upward displacement of approximately 2.5 inches, and the upper slab underwent minor displacement. Cracks were observed throughout the model. When facing the model, it was obvious that the upper beam on the left side of the model incurred minor, but noticeable upward bowing. The achieved damage level was considered great enough to proceed with using cmu walls in the next experiment.

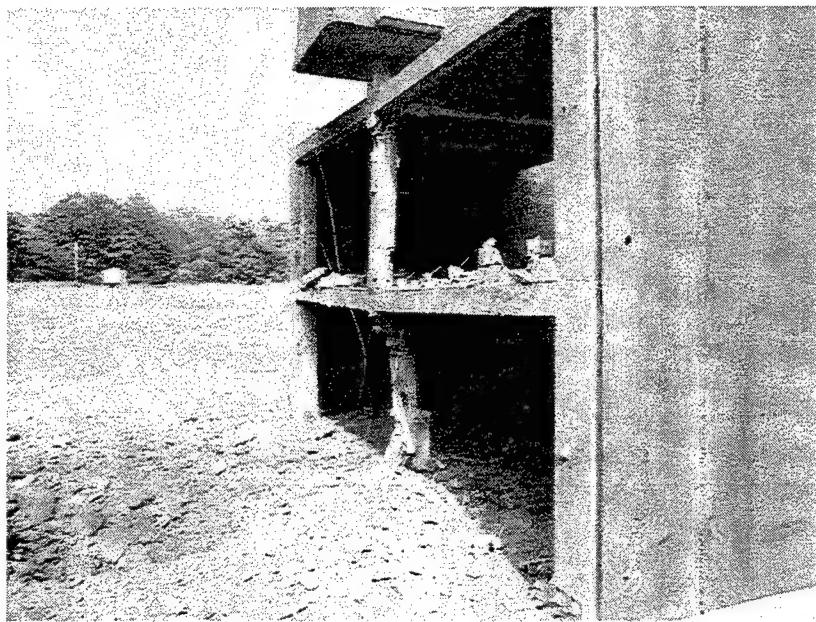
Figure 3.7 Posttest View, Experiment No. 3

The standoff of 3.5 feet was maintained for experiment no. 3. The front face of the model was fully clad with the $\frac{1}{4}$ scale cmu masonry. Figures 3.7 through 3.9 are posttest photographs. The lower section of the test column deflected approximately 4.5 inches, and the upper section deflected approximately 1 inch. It is obvious that the lower section of the test column could not carry any significant compressive load. Collapse of the structure under the applied weight was avoided by the action of the edge beams. The beams appeared to bridge over the column and transfer the forces to the corner columns. The upper section of the column was also capable of providing some connection between the lower and upper edge beams. Due to presence of the walls, the slabs sustained very minor damage with only hairline cracks.

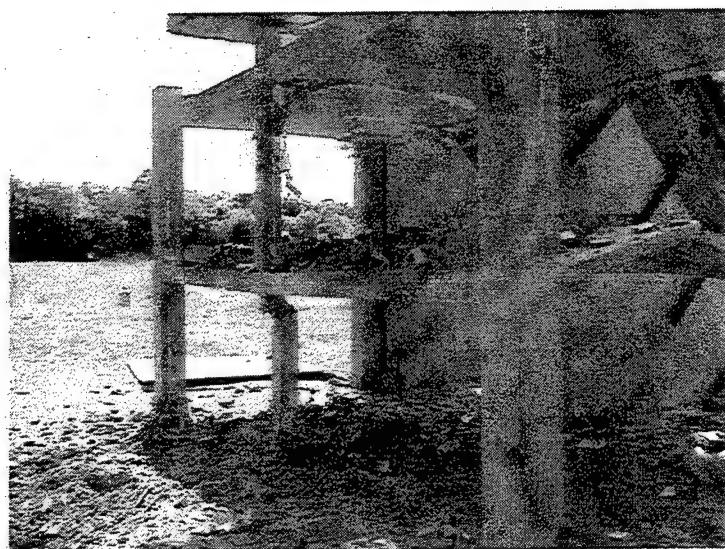
Figure 3.10 Posttest View, Experiment No. 4

Experiment no. 4 differed from experiment no. 3 in that openings (equivalent to 33 percent of the wall area) were present in each of the four front walls. Figures 3.10 through 3.12 are posttest photographs. The lower section of the column deflected approximately 3 inches, and the upper section deflected approximately 9/16 inch. The column displacements were less than that of experiment no. 3, but the presence of a section of cmu wall adjacent to the columns did increase the impulse to the column as compared to the open frame configuration of experiment no. 2. Unlike the case for experiment no. 3, the lower slab did sustain significant damage. The permanent upward displacement was approximately 6.5 inches. The presence of the window openings allowed direct blast loading to the under surfaces of the slabs. In the case of the lower slab, the locations of the openings resulted in an increased differential loading on the slab surfaces that contributed to the uplift. As in experiment no. 3, the beams bridged over the destroyed column.

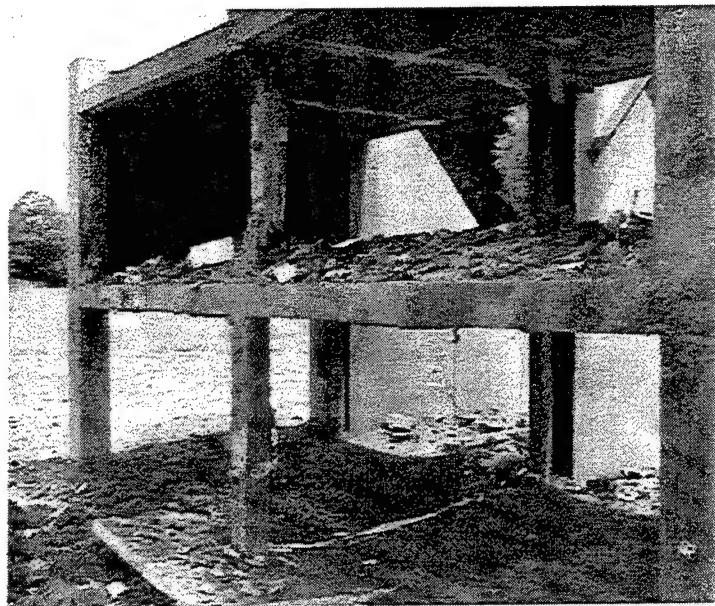
Figure 3.13 Posttest View, Experiment No. 5

The presence of an upper wall but no lower wall is likened to the parking garage configuration. The standoff of 3.5 feet was used. Figures 3.13 through 3.15 are posttest photographs. As expected, the lack of a lower wall resulted in minor damage to the lower column as in experiment no. 2. The presence of an upper wall resulted in significant damage to the upper column as in experiment no. 3. Due to the presence of the upper wall, the lower slab of this model experienced the greatest top/bottom load differential of all the models. Consequently, the lower slab incurred a permanent upward displacement of approximately 8 inches. The upper section of the column had a permanent displacement of approximately 3 inches. The upper edge beam bridged over the failed column to support the applied weight.

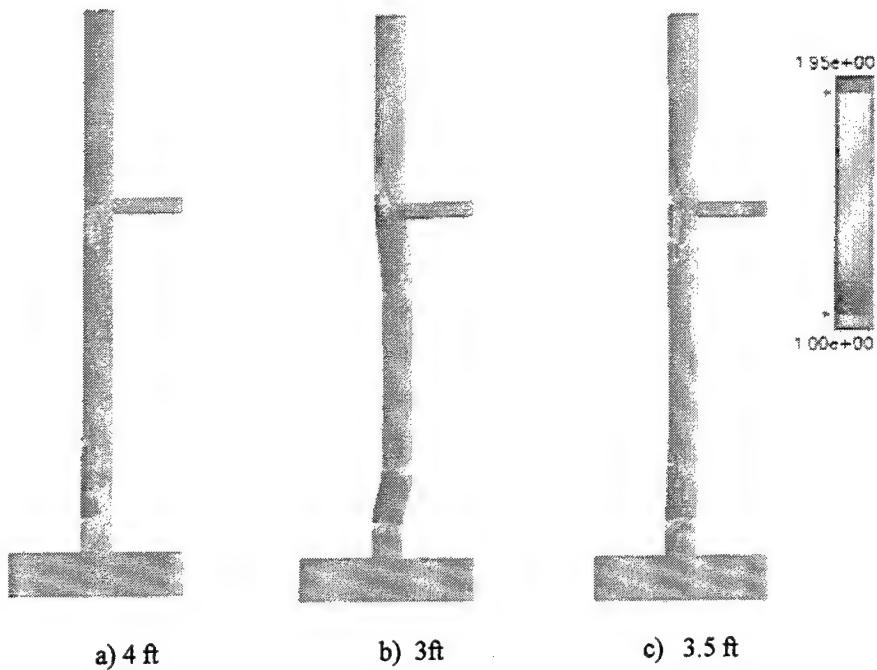
Figure 4.20 Effect of charge standoff on damage to column

Displacement histories at the center of the lower level column are shown in Figure 4.19, and structure damage plots are shown in Figure 4.20. The displacements and structural damage predicted for the 4-ft standoff were only slightly more than those for the 5 ft standoff. The analyses for the 3-ft standoff indicated that the center of the column would displace about 1 in. but would not fail. In the damage fringe plots shown in Figure 4.20, a damage value of 1.0 means that the concrete has hardened from its yield capacity to its maximum capacity. A damage value of 2.0 indicates that the concrete has softened to its residual capacity (i.e. the concrete is completely failed and will behave similar to sand).

Those areas shown in red in Figure 4.20 have a damage value greater than 1.95, indicating that those areas of the concrete have failed. Although the analysis indicated that the column would not fail at a standoff of 3 ft, the degree of damage predicted to the column, indicated that it was very close to failure.

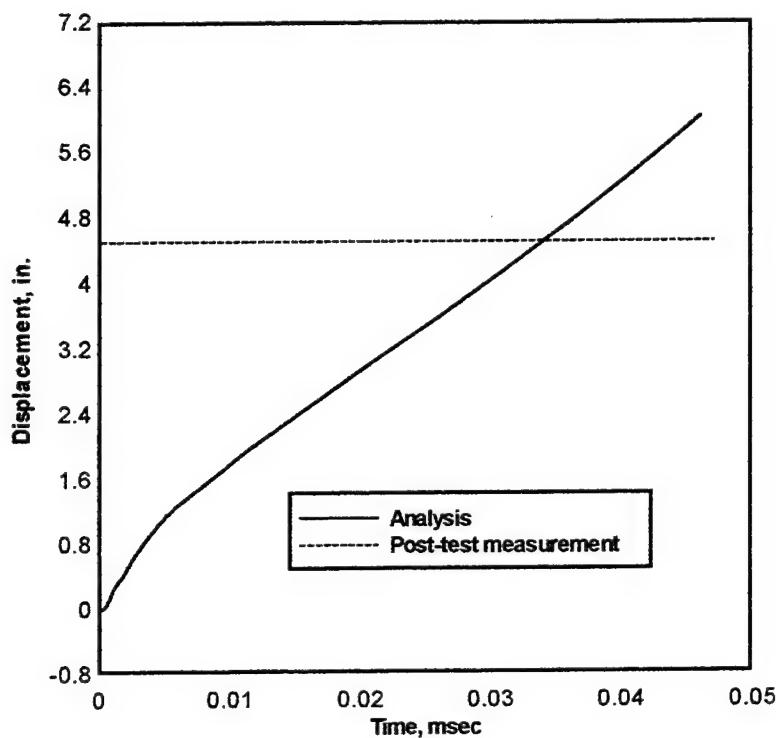
Figure 4.37 Displacement of center of lower level column, Test 3

The predicted response of the center of the column is shown in Figure 4.37. This figure indicates that the column will continue to deform and will fail. The post-test inspection indicates a failure with a maximum horizontal displacement of 4.5 in. In the experiment, the edge beams did not fail, and once the top of the column moved down approximately 2 in., the beams could support the dead load applied to the top of the column. In the analysis, the edge beams could not support vertical loads, therefore, once the column fails, the moments caused by the product of the dead load with the horizontal displacement of the column cause the column to continue to deform. The predicted response of the column at 30 msec after detonation is shown in Figure 4.38. This figure demonstrates that by 30 msec, the top of the column would have moved down about 2.2 in. By this time there would be no loads applied to the column. At this time, the horizontal displacement in the analysis (4.26 in.) approximately matches the maximum displacement measured in the experiment. The severe damage at the top and bottom of the lower level column shown in red in Figure 4.39 are consistent with the damage observed in the experiment, and the deformed shape matches that of the post-test photograph.
